Transport
Canada

Issue 3/2011

Feedback

Canadian Aviation Service Difficulty Reports

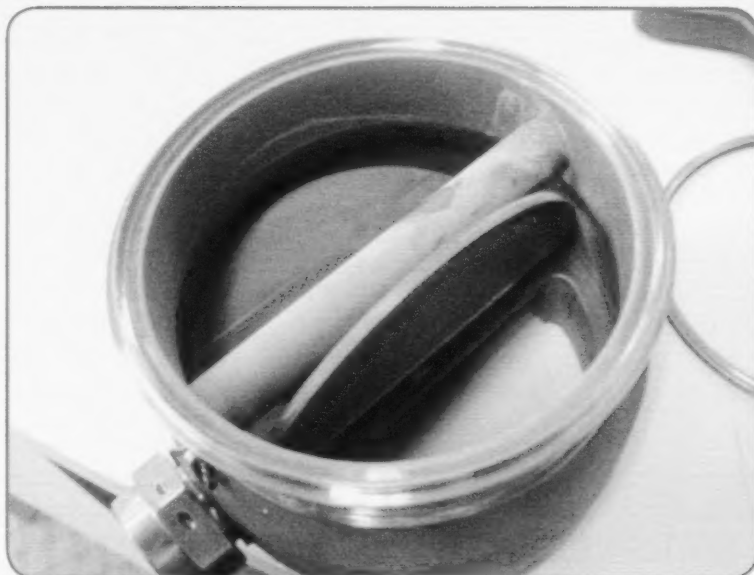
During descent with the auto-throttle (a/t) engaged, the flight crew encountered a left engine surge and intermittent stalls. The crew disengaged the a/t and using manual throttle inputs, were able to sufficiently control the engines tendency to surge.

The engines parameters remained normal during descent and made an uneventful landing. During maintenance taxi to the hangar, the left engine fuel flow was fluctuating slowly between 700 and 800 lbs/hr. When the thrust levers were advanced slightly, the left engine started to shake and vibrate with subsequent annunciation of an engine fail message and an automatic engine shut down occurred.

Maintenance personnel accomplished FIM 71-05 task 805 and subsequently found the 5th stage compressor check valve stuck open. The valve was replaced as the corrective action and the aeroplane was returned to service.
